Inside & Out Home Inspection, Winsted, CT 06098

Building Inspection Report

**28 Adams Street
Goshen, CT 06756**

Inspection Date: **03-23-17**

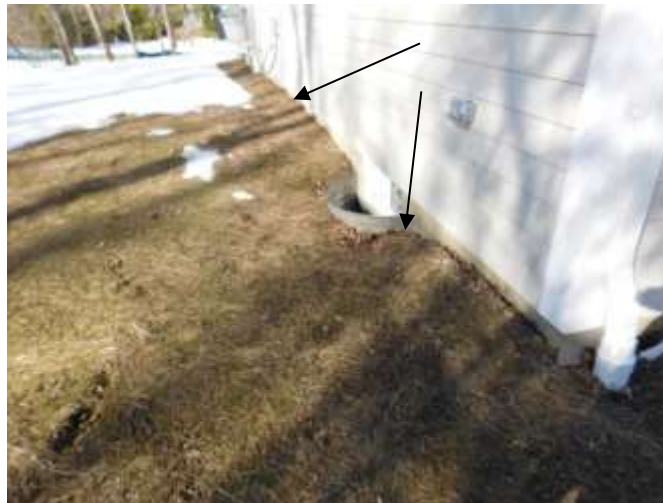
- 2. Window wells on the right side are installed too low. Insufficient soil is installed along the foundation. Wells need to be raised and additional top soil added.**

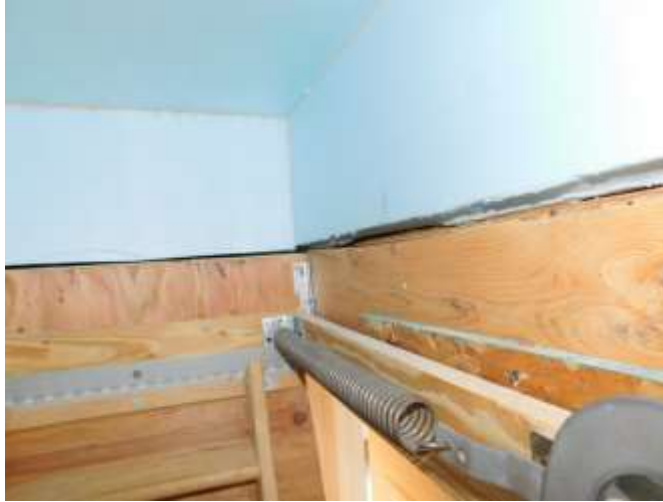
1. Heat loss occurs through the pull-down attic stairs in winter weather. The cover installed does not seal tightly against the floor and allows heat loss from the building. A gasket can be installed on the door. Proper fitting covers can be purchased: <http://insulattic.com/>
<http://www.attictent.com/>
